EFFLORESCENCE – INFO SHEET

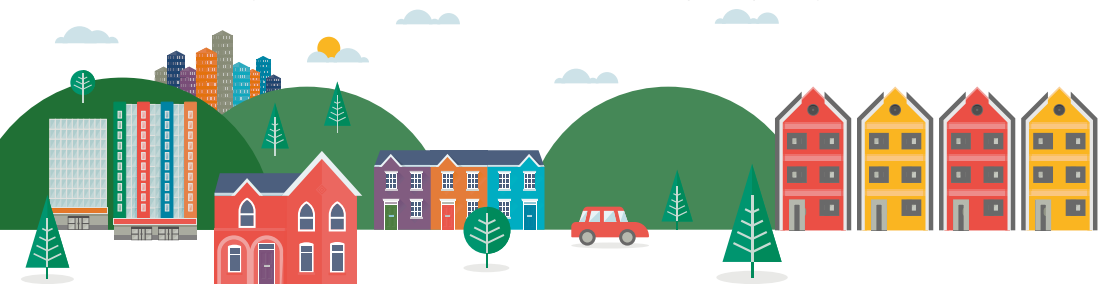
Because of the nature of the build up process involved in Lime Weeping it is most likely to be noticed later in the life of a building or structure. Lime Weeping is not generally a cause for concern

but does demonstrate that water is moving through a structure. If this structure is likely to be damaged by this process then remedial action may be required.
